Manhole Inspection Summary

Manhole # S25Q__010MH

Insp Date: **4/9/08 12:07 PM**

Location Address: **1501 BUSH ST.**

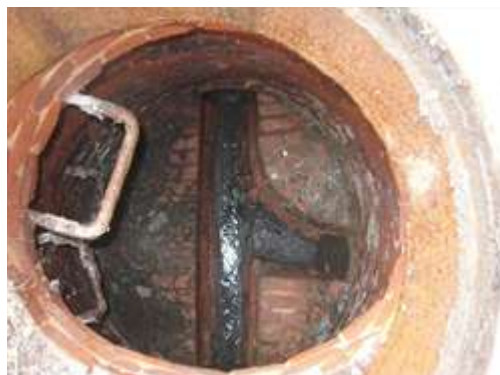
Top View

debris on bench

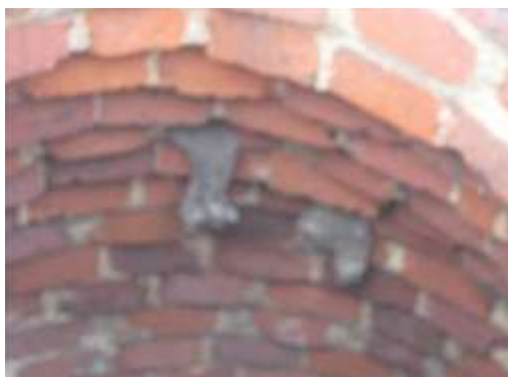
Defect 3

EVIDENCE OF SURCHARGE ON CORBEL WALL

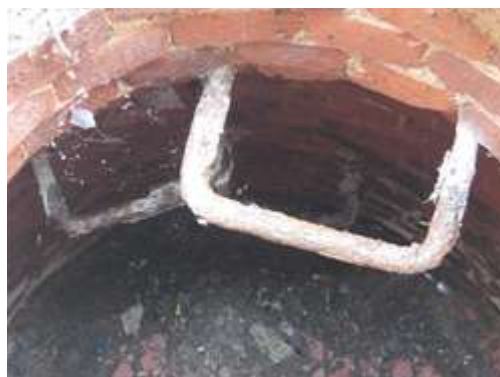
Defect 2

CORRODED STEPS AND DEBRIS ON BENCH

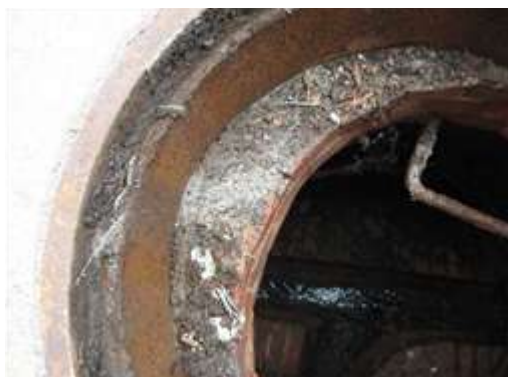
Defect 1

2.5 IN FRAME OFFSET WITH EVIDENCE OF SURCHARGE

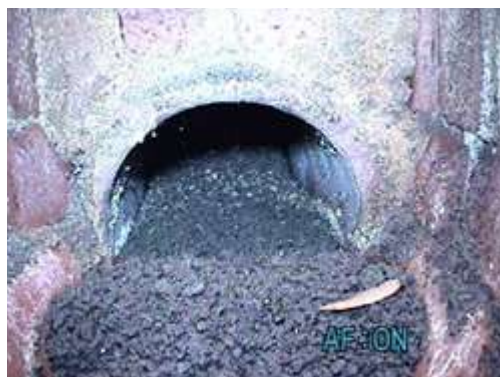
Defect 4

channel cond debris

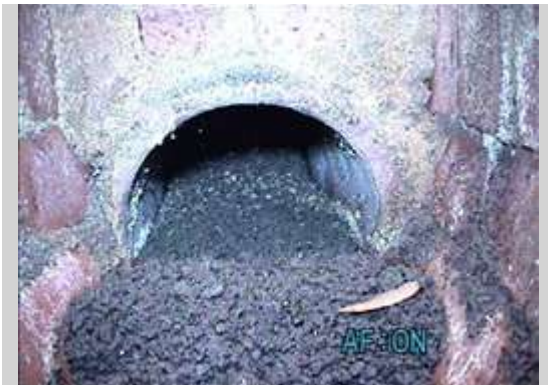
3 O'Clock Inflow

mud sediment build up in channel

Pipe Height: **6** (in.) Rod and Bar (Angled)
Pipe Material: **Clay** ☐ Pipe Lined
Invert Depth: **6.88** (ft.) Flow Characteristics: **None**
Deposits: ☐ None ☒ **Mud** ☐ Sludge ☐ Debris ☐ Grease
Silt Depth: **4** (in.) Deposits Extent: **Medium**
Infiltration: **None** Pipe Seal Cond: **Sound**
